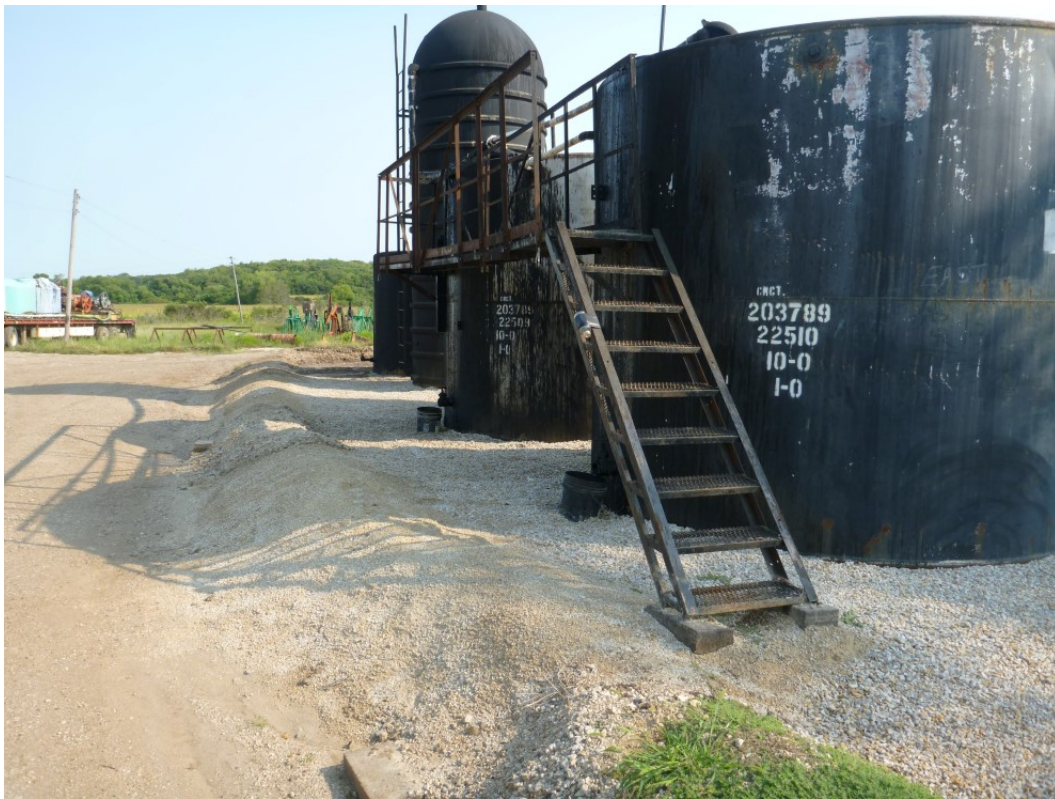
Photo: # 1 Site: D&Z Exploration, Inc. - Hastert East Lease, Garnett, KS Date: 8/26/2015
 Time: AM Direction: North Photographer: Paul Doherty, EPA Witness: Deke Belden, D&Z Exploration
 Description: Hastert East Lease tank battery. The plan states that the dike height is 1.5 feet which is not obvious from field observations.

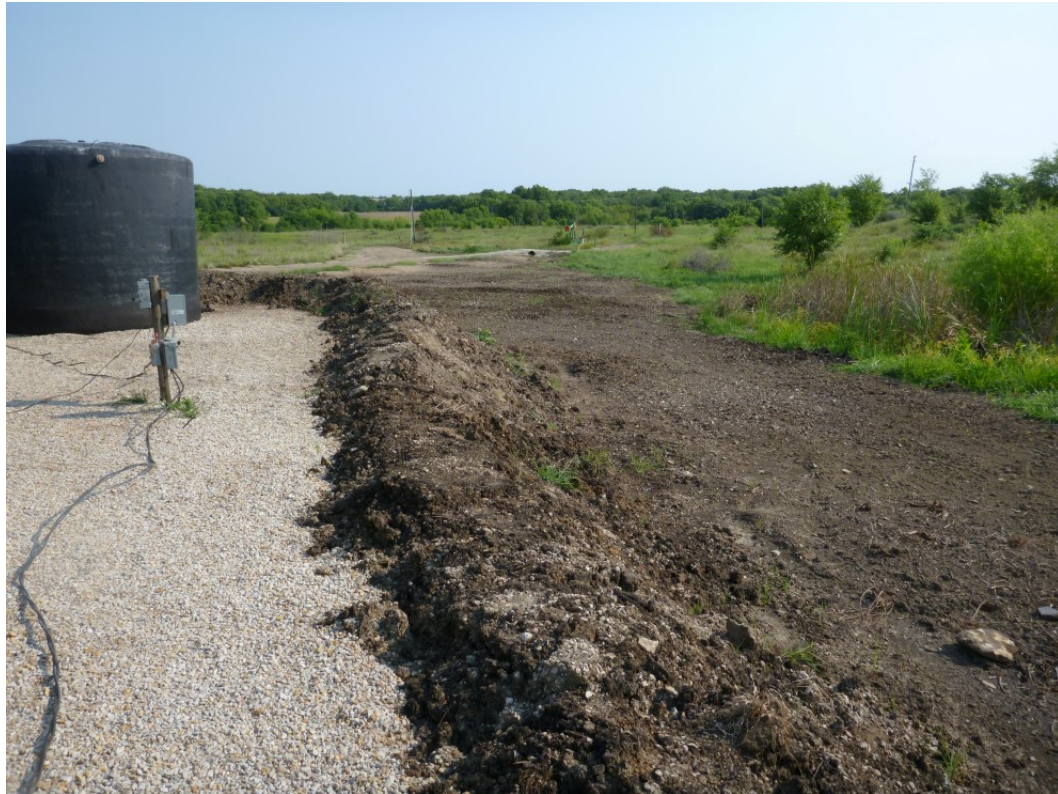
Photo: # 2 Site: D&Z Exploration, Inc. - Hastert East Lease, Garnett, KS Date: 8/26/2015
 Time: AM Direction: North Photographer: Paul Doherty, EPA Witness: Deke Belden, D&Z Exploration
 Description: Hastert East Lease dikes have been reconstructed and oil inside and outside containment has been removed by ongoing remediation actions. Gypsum has been applied to soil outside containment at the direction of the KCC.

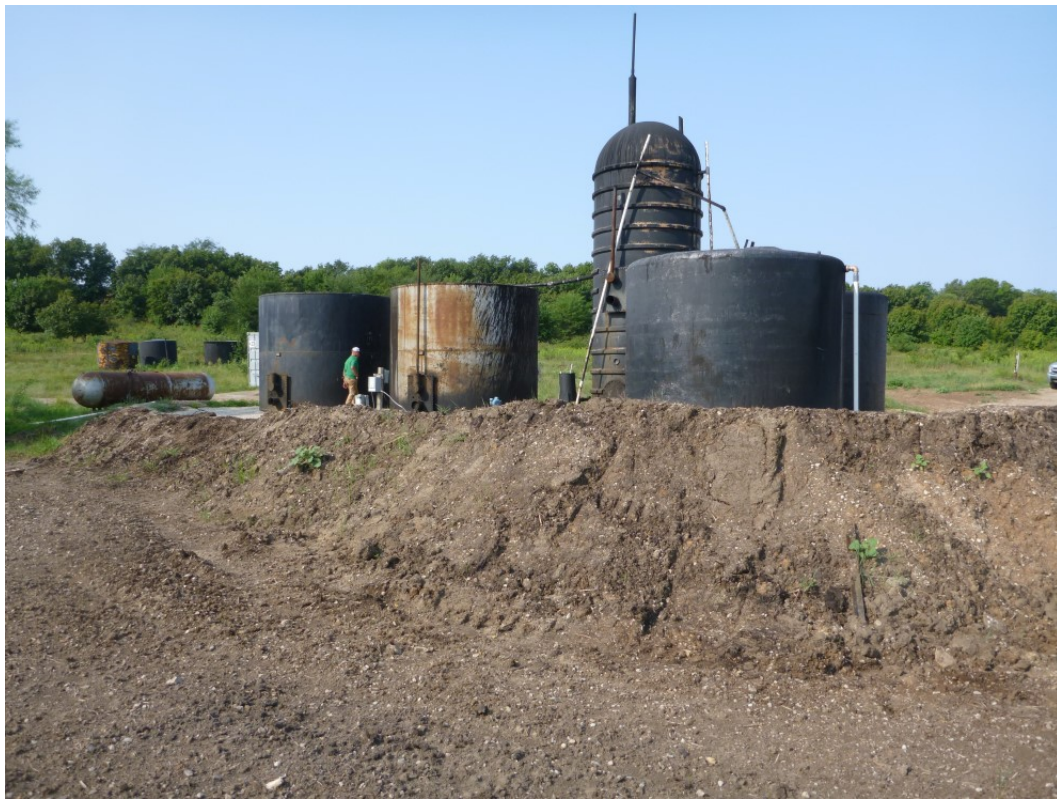
Photo: # 3 Site: D&Z Exploration, Inc. - Hastert East Lease, Garnett, KS Date: 8/26/2015
 Time: AM Direction: Southeast Photographer: Paul Doherty, EPA Witness: Deke Belden, D&Z Exploration
 Description: Northeast corner of containment has been reconstructed and oil contaminated soil has been excavated and the ground treated with gypsum under KCC over sight.

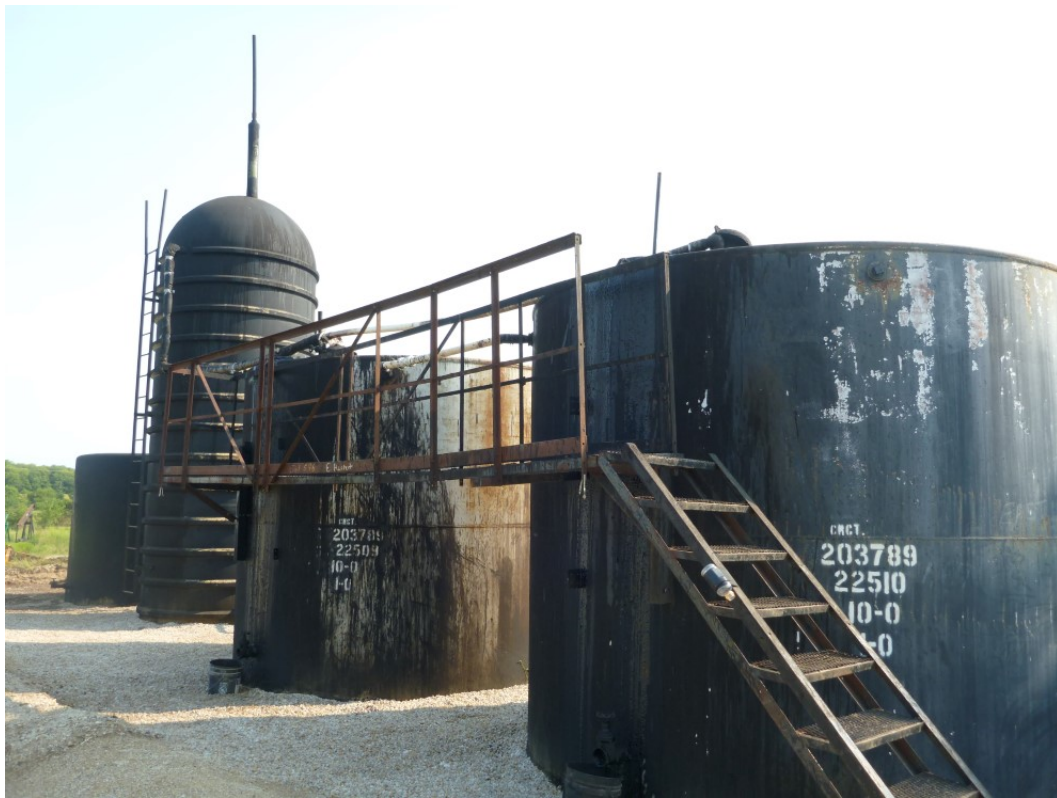
Photo: # 4 Site: D&Z Exploration, Inc. - Hastert East Lease, Garnett, KS Date: 8/26/2015
 Time: AM Direction: Northeast Photographer: Paul Doherty, EPA Witness: Deke Belden, D&Z Exploration
 Description: View Hastert East Lease tank battery inside containment.

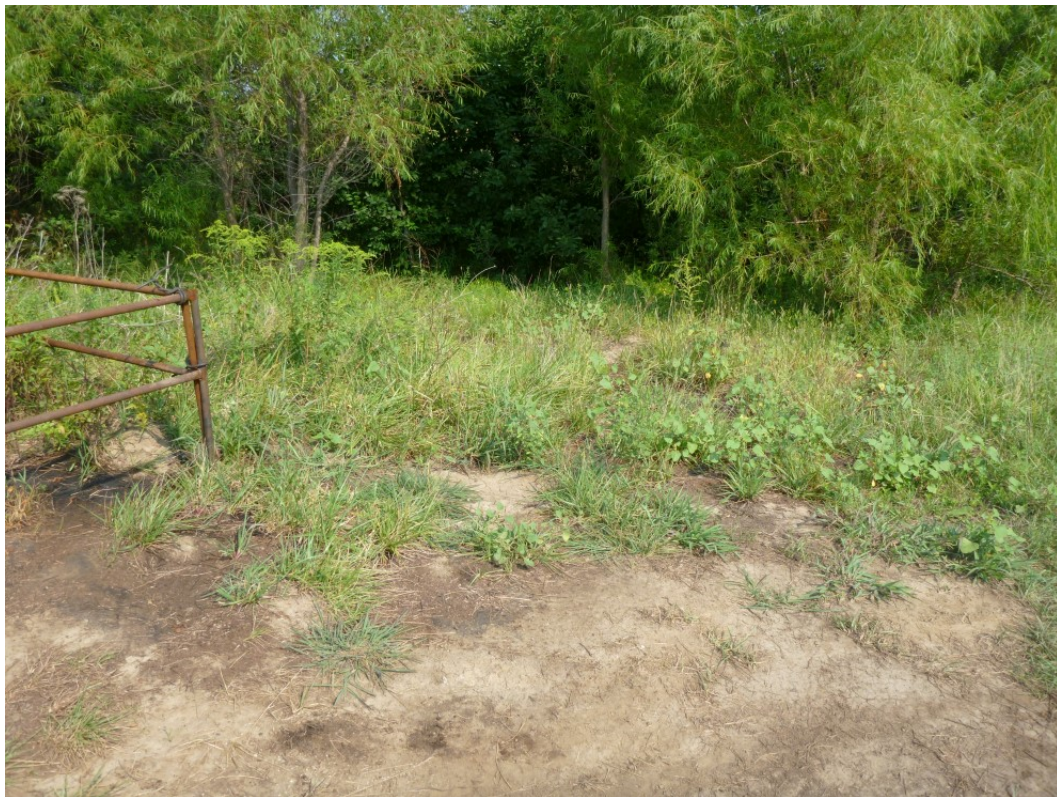
Photo: # 5 Site: D&Z Exploration, Inc. - Hastert East Lease, Garnett, KS Date: 8/26/2015
 Time: AM Direction: North Photographer: Paul Doherty, EPA Witness: Deke Belden, D&Z Exploration
 Description: Example of wellhead in proximity to surface water (in background).

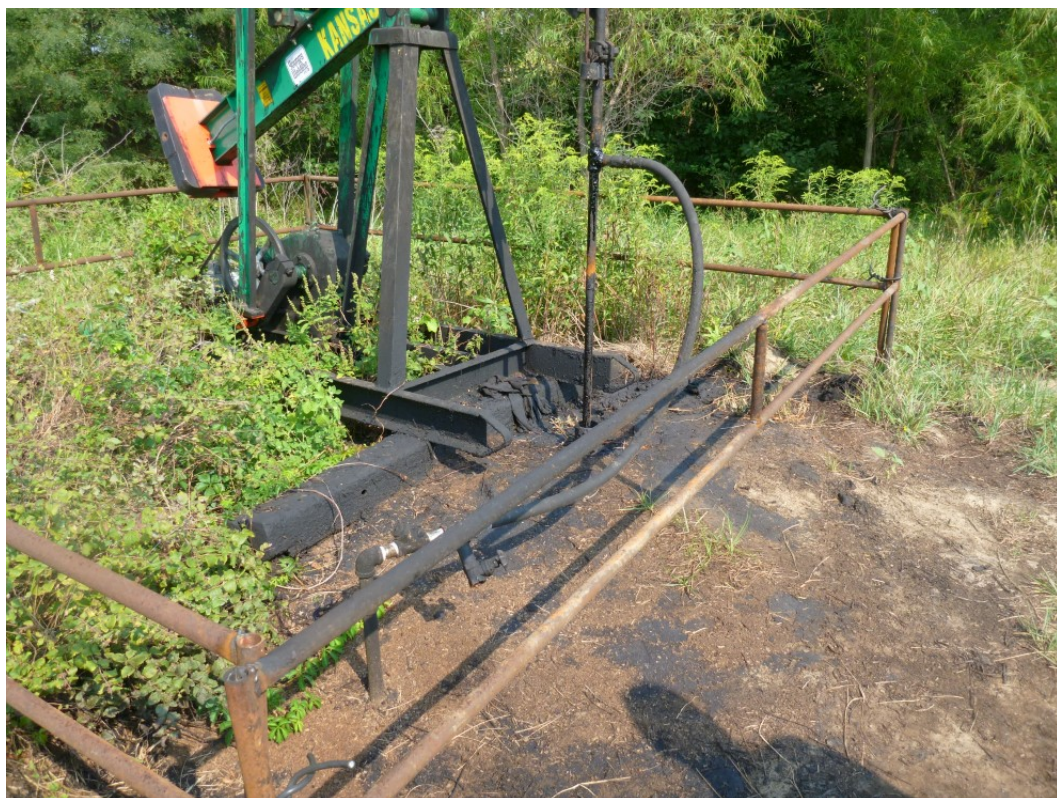
Photo: # 6 Site: D&Z Exploration, Inc. - Hastert East Lease, Garnett, KS Date: 8/26/2015
 Time: AM Direction: Northwest Photographer: Paul Doherty, EPA Witness: Deke Belden, D&Z Exploration
 Description: Another view of wellhead in proximity to surface water (in background). Peat moss absorbent applied to oil leakage at well head pump rods was indication that there is an active gathering line maintenance program in place.

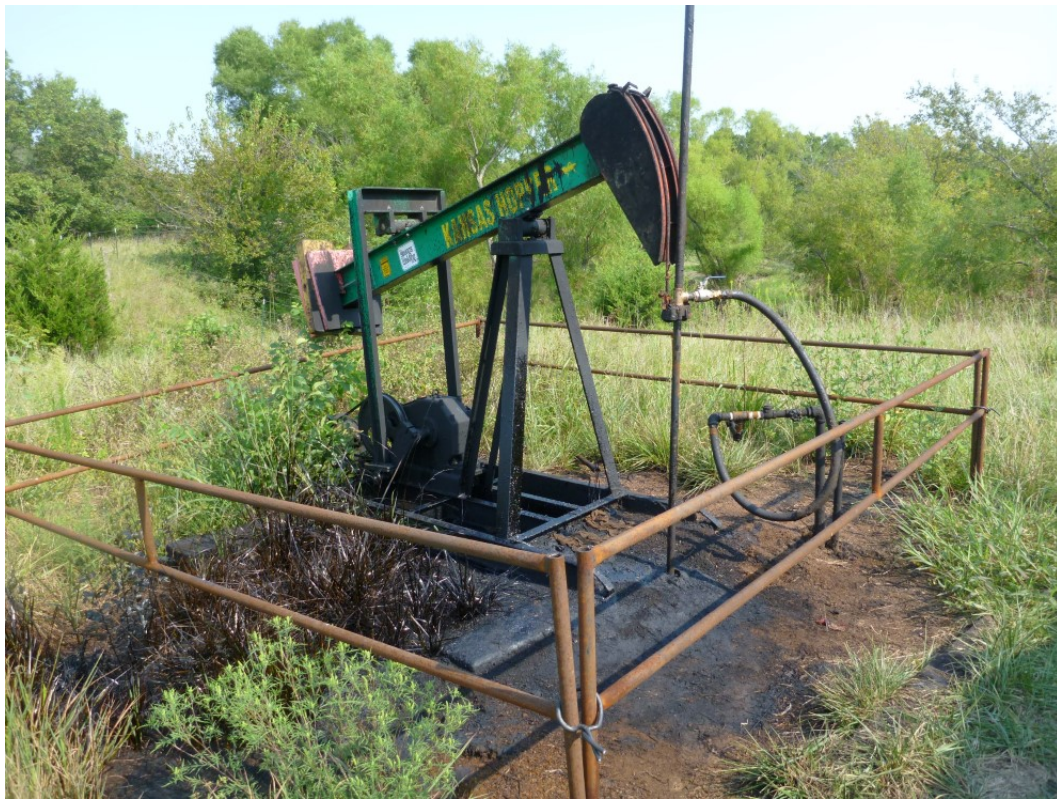
Photo: # 7 Site: D&Z Exploration, Inc. - Hastert East Lease, Garnett, KS Date: 8/26/2015
 Time: AM Direction: Northwest Photographer: Paul Doherty, EPA Witness: Deke Belden, D&Z Exploration
 Description: Evidence of a well head rod bushing/gasket leak that had not yet been attended to. The situation was pointed out to the operator who agreed to address the situation.

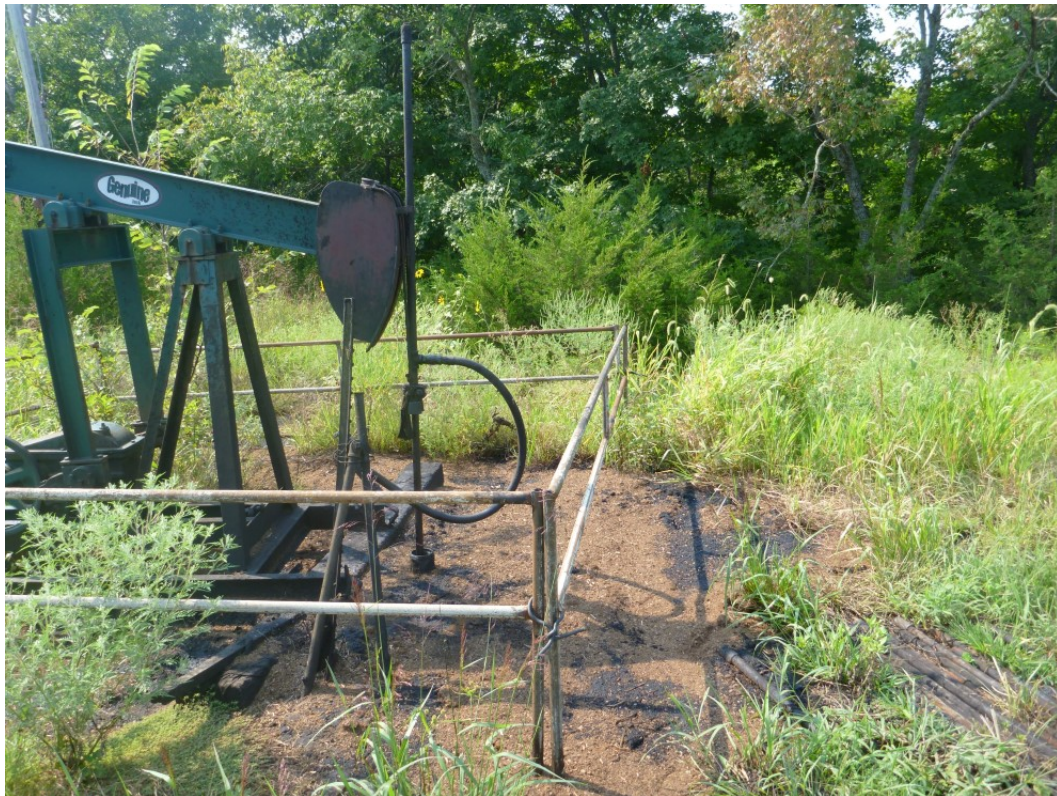
Photo: # 8 Site: D&Z Exploration, Inc. - Hastert East Lease, Garnett, KS Date: 8/26/2015
 Time: AM Direction: Northwest Photographer: Paul Doherty, EPA Witness: Deke Belden, D&Z Exploration
 Description: View of peat moss absorbent applied to old well head oil release. Visual evidence was that the release had occurred under the previous lease operator and had run some distance away from the well head.

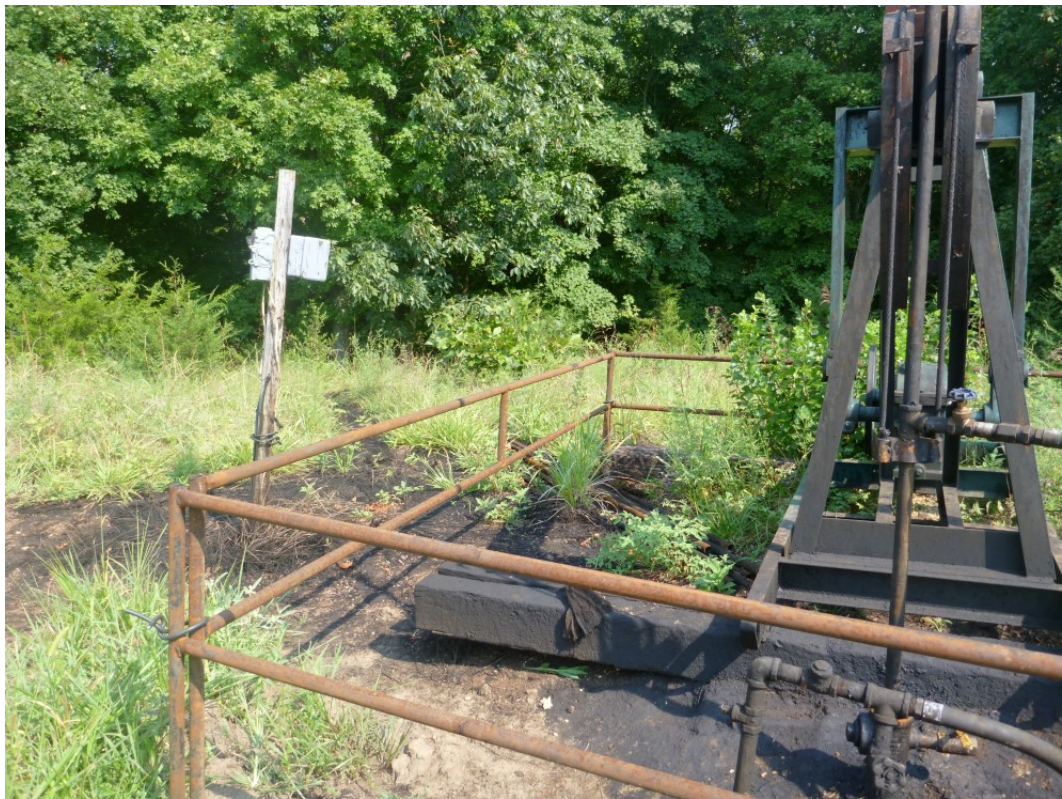
Photo: # 9 Site: D&Z Exploration, Inc. - Hastert East Lease, Garnett, KS Date: 8/26/2015
Time: AM Direction: Northwest Photographer: Paul Doherty, EPA Witness: Deke Belden, D&Z Exploration
Description: Another well head where peat moss absorbent has been applied to old well head oil release. Visual evidence was that the release had occurred under the previous lease operator and had run some distance away from the well head.
